IMPACT RESISTANCE OF
COMPOSITE FAN BLADES

E. J. PREMONT
K. R. STUBENRAUCH

PRATT & WHITNEY AIRCRAFT
DIVISION OF UNITED AIRCRAFT CORPORATION

1. Report No. NASA CR-134515		2. Government Accession No.		3. Recipient's Catalog No.	
4. Title and Subtitle Impact Resistance of Composite Fan Blades Final Report				5. Report Date May 1973

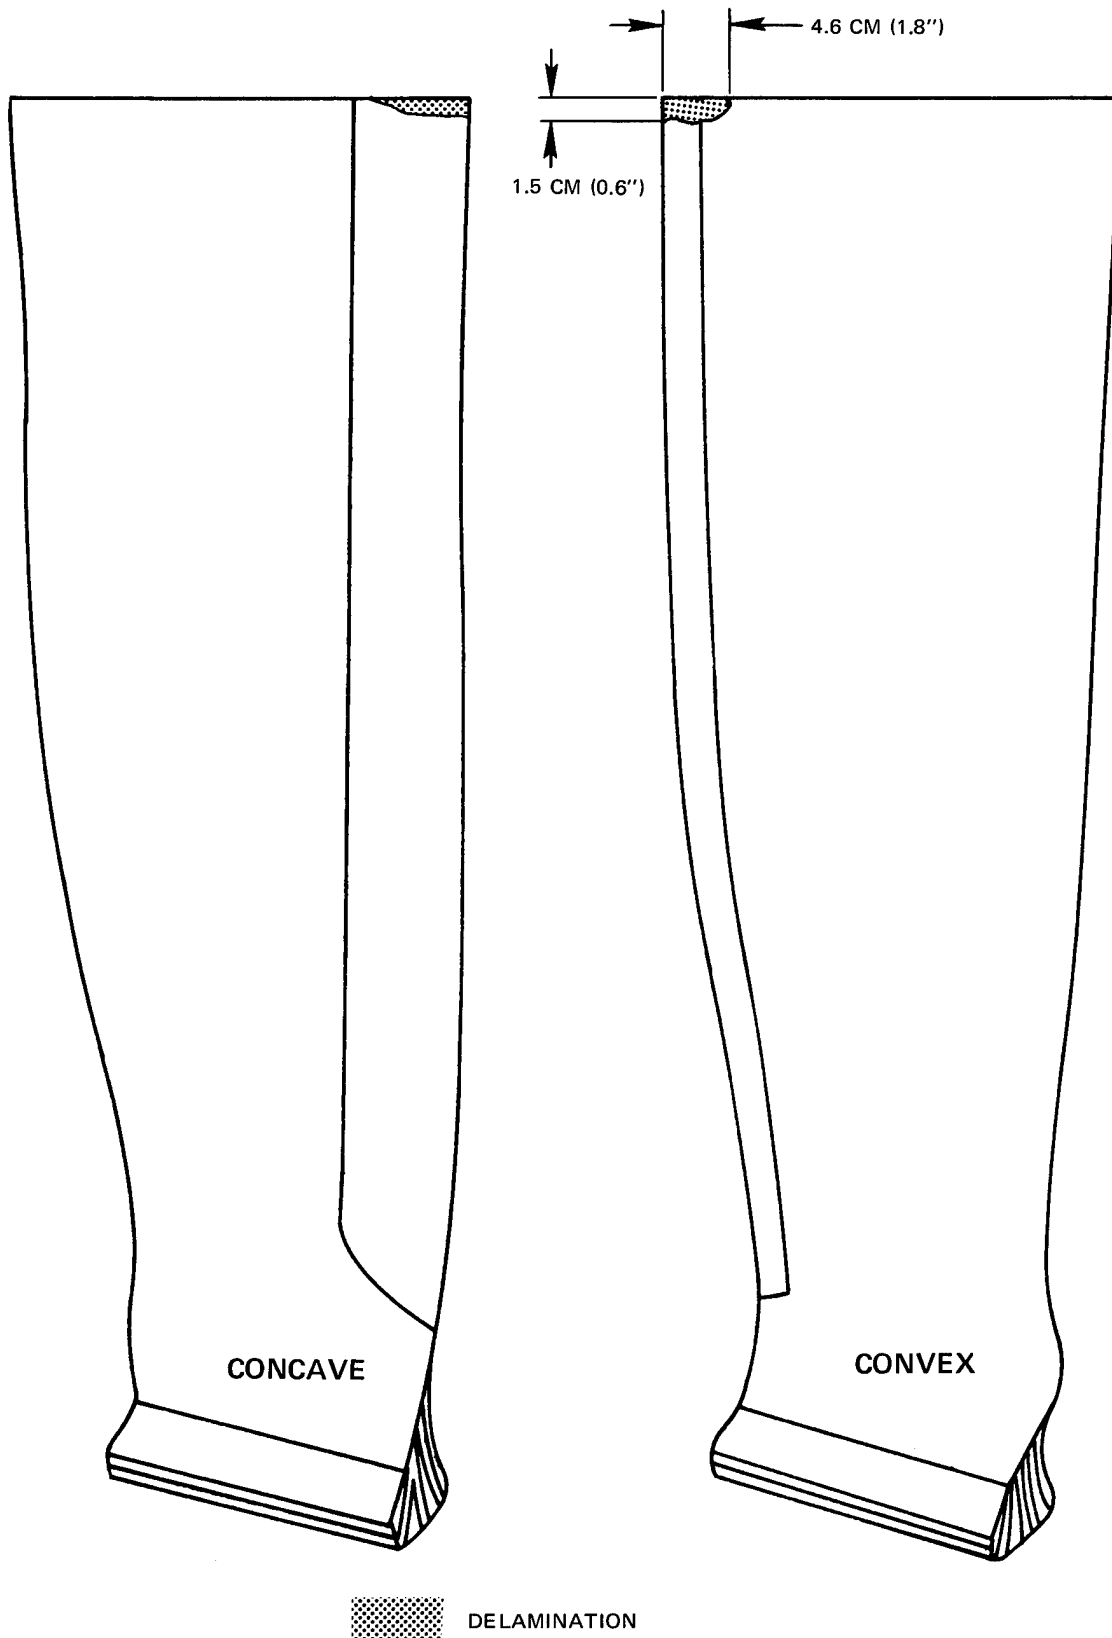
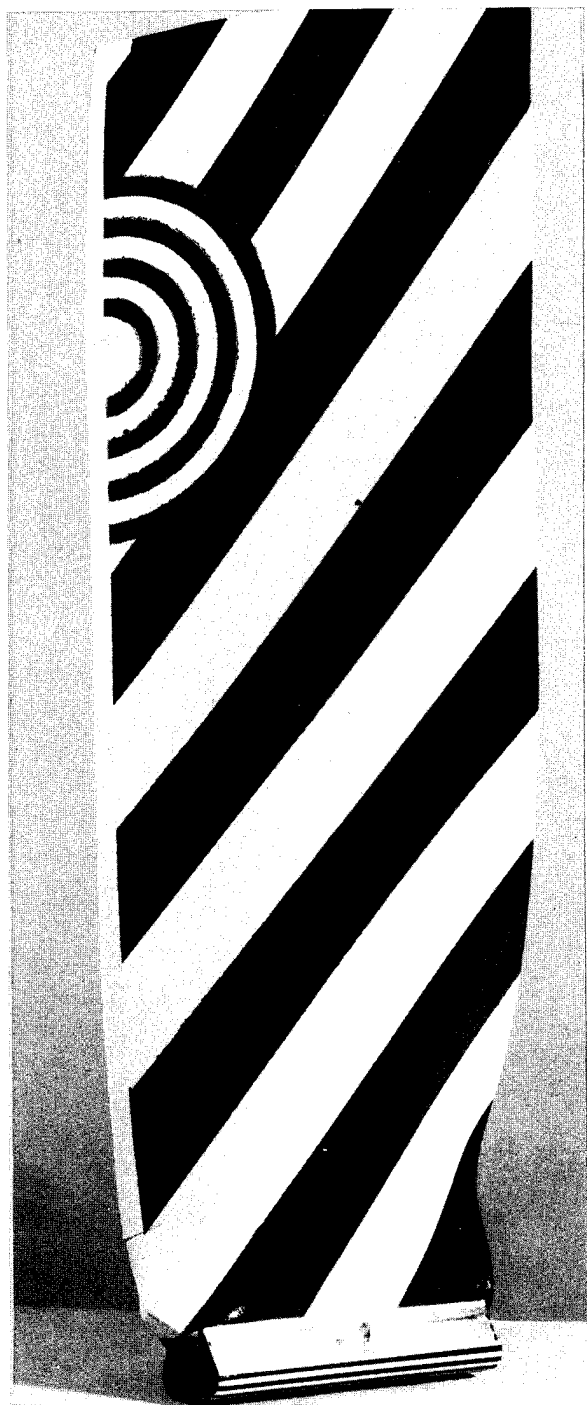
Figure 23 Visual Damage to Graphite/Epoxy Blade C-1 Following Impact with Ice Ball

In the 5.1 cm (2.0 in) diameter ice ball impact tests of blades C-1 and B-1, the high speed movies showed that the ice ball shattered upon contact with the blade leading edge in each case. Visual damage to the two blades after impact with the 75g (2.6 oz) ice balls is shown schematically in Figures 23 and 24 and pictured in Figures 25 and 26. The small area of composite delamination on blade C-1 was in the area where ultrasonic indications of poor consolidation was found during pre-test NDI. This ultrasonic area grew during testing, as shown in Figure 27. The tip deflection caused by the impact tends to further loosen any existing delamination. Due to the designed thinness of the composite at the blade tip leading edge, the impact has an increased effect on this area.

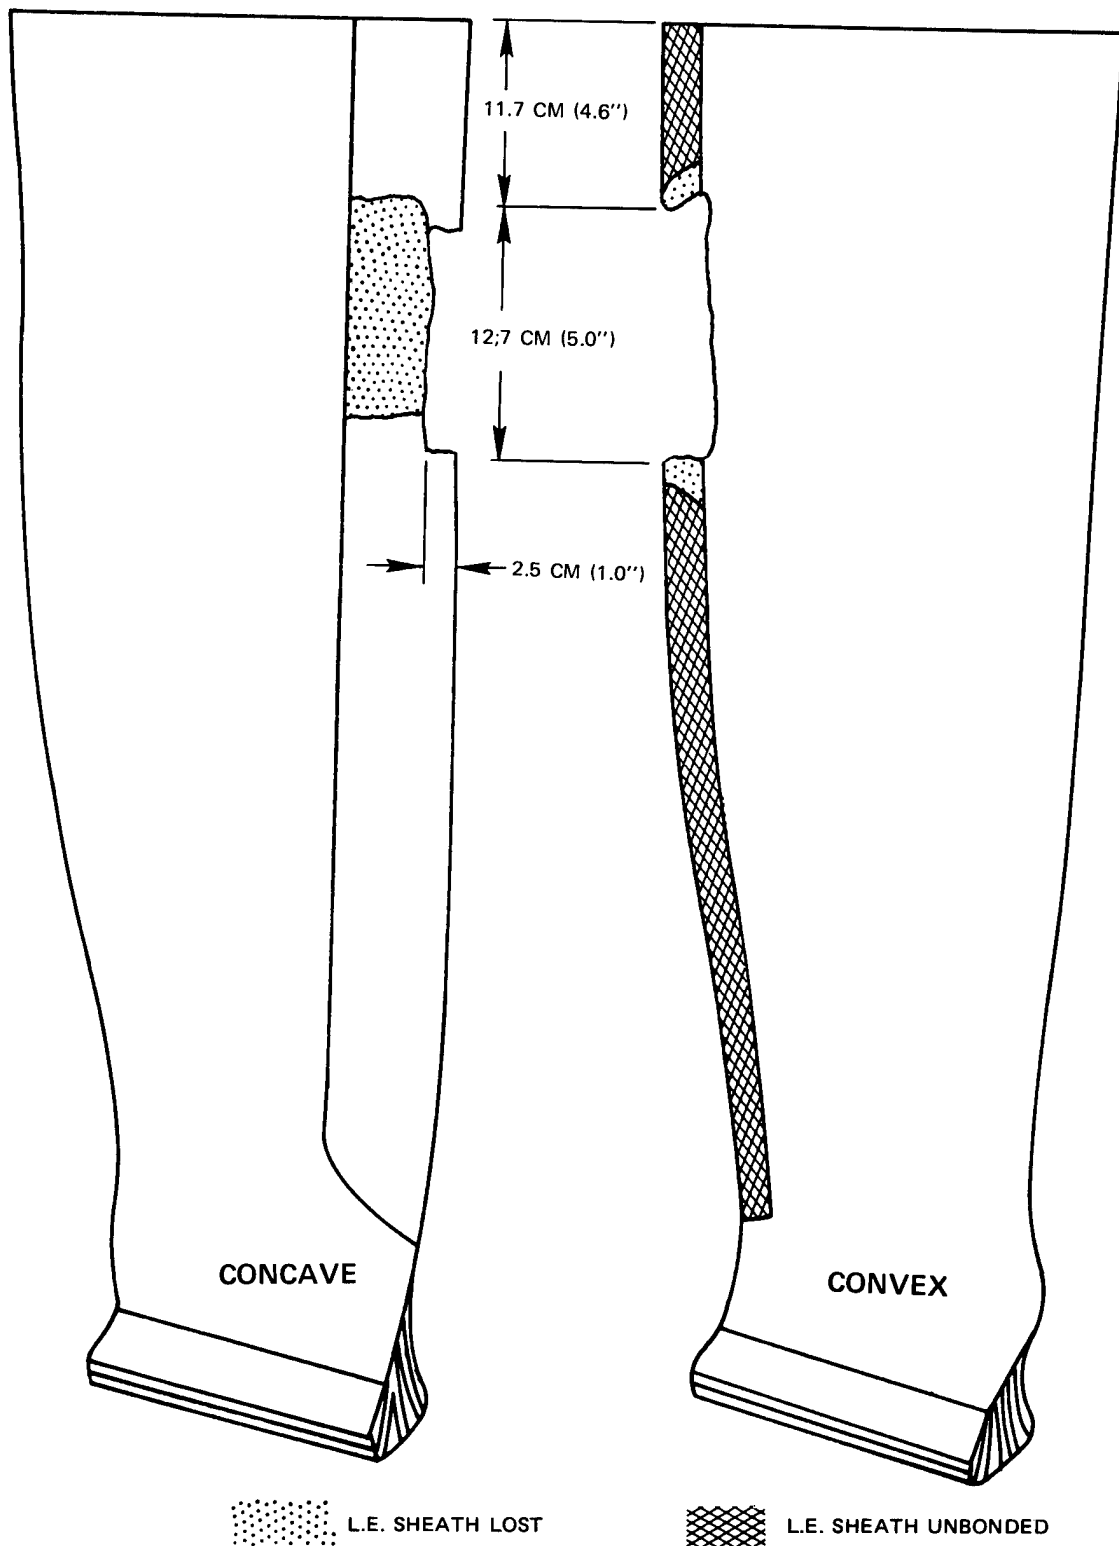
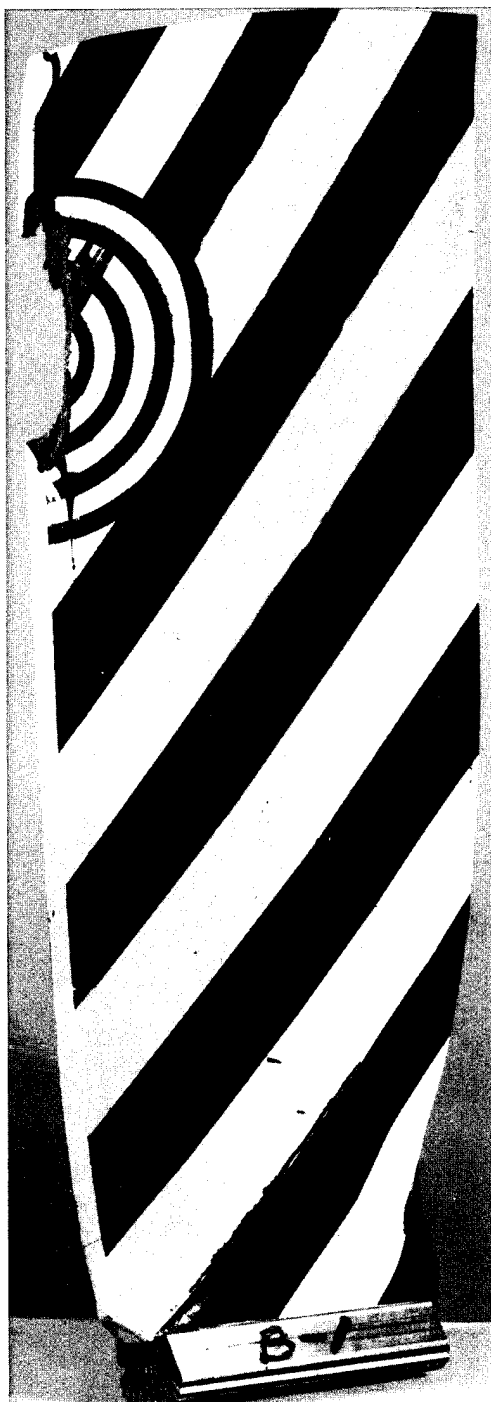
Figure 24 Visual Damage to Boron/Epoxy Blade B-1 Following Impact with Ice Ball

The damage to blade B-1 from the ice ball impact was more severe, however, no post-test ultrasonic indications were found. High speed movies show that blade B-1 took a large slice of the ice ball (approximately three-quarters of the ball), whereas blade C-1 hit the ice ball at its mid-point. This seems to be the only factor which affected the amount of damage sustained by each blade. The difference in FOD was not expected due to the composite material differences. The FOD threshold is very likely close to the ice ball weight of 75g (2.6 oz).

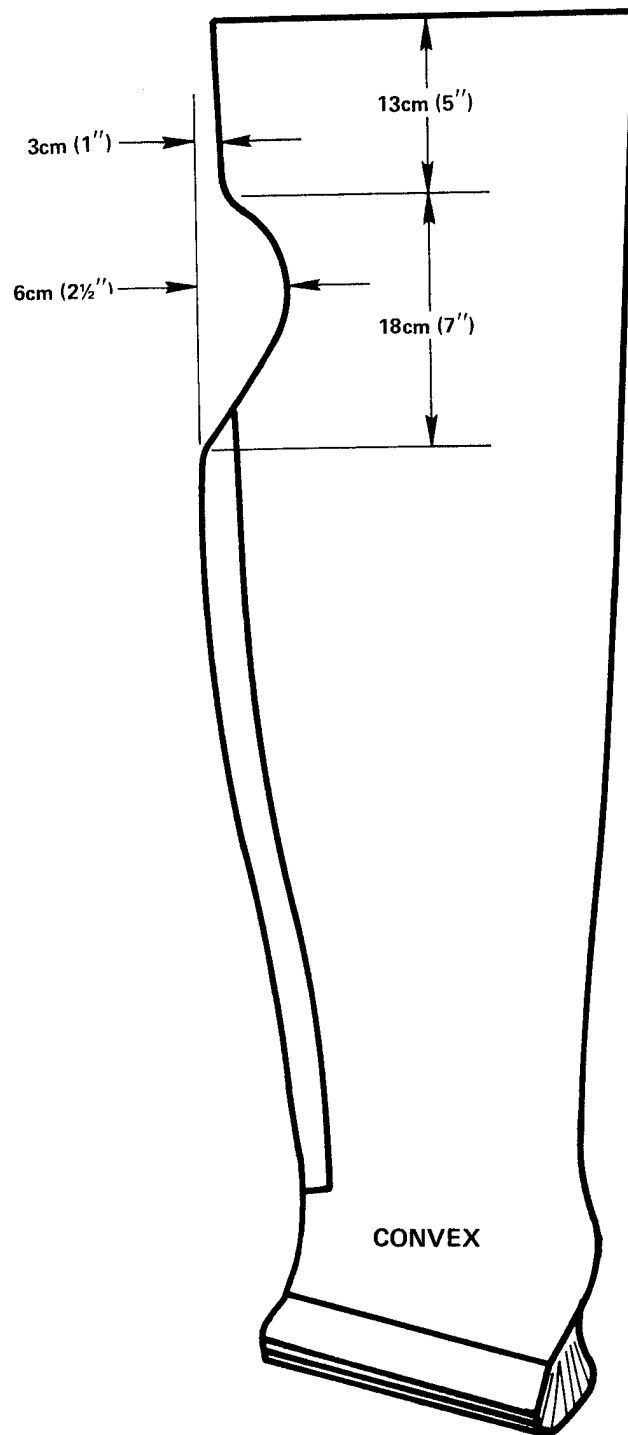
Figure 29 Estimated Damage to Graphite/Epoxy Blade C-2 Following the First Impact with 320g Gelatin Ball

The 320g (11.2 oz) gelatin ball impact caused damage to graphite/epoxy blade C-2 as sketched in Figure 29 estimated from the final sequence photo of Figure 28. The high-speed movies revealed that the slice size for this first impact was approximately 110g (3.8 oz). In this test, the object catching system failed to prevent a second impact. The remaining 210g (7.4 oz) piece of gelatin ball hit the blade inboard of Section K-K where the airfoil chord angle is greater. The damage from both impacts is sketched in Figure 30 and pictured in Figure 31. Post-test ultrasonic indications correspond to the delaminated area shown in Figure 30.

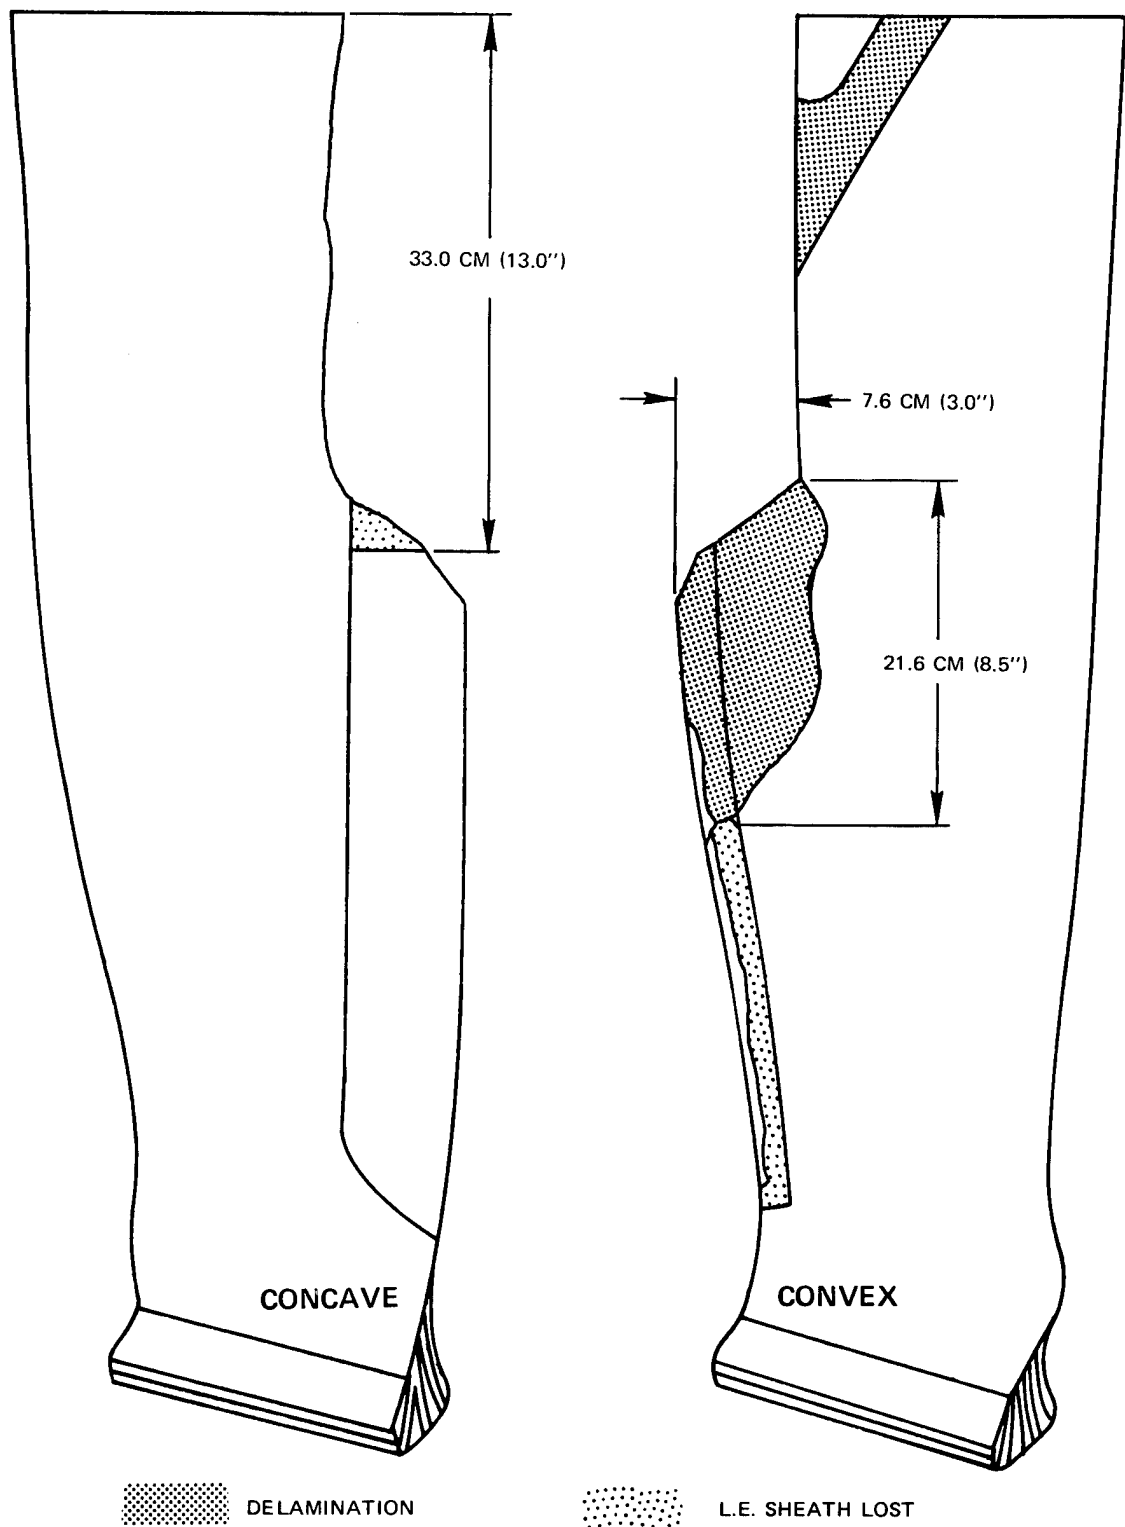
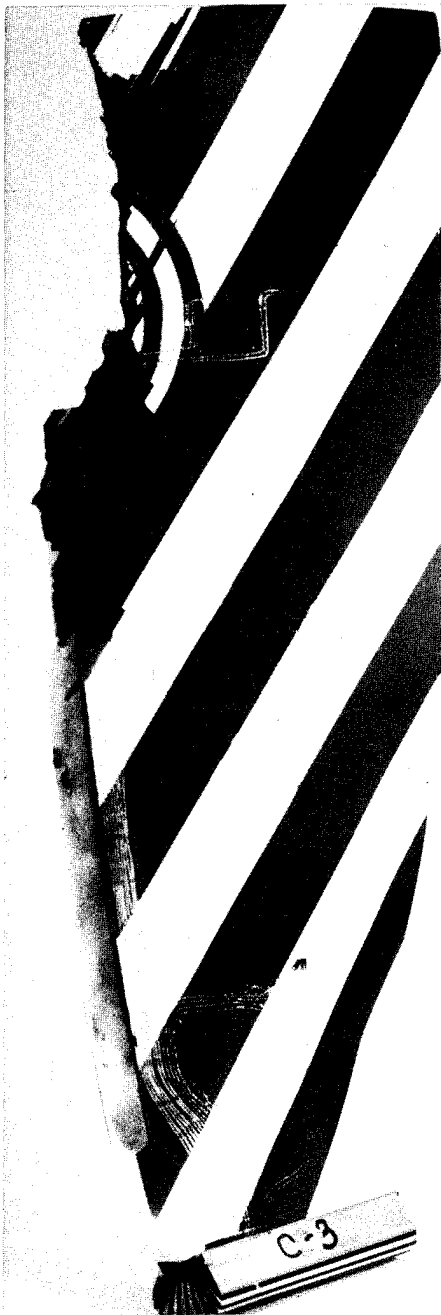
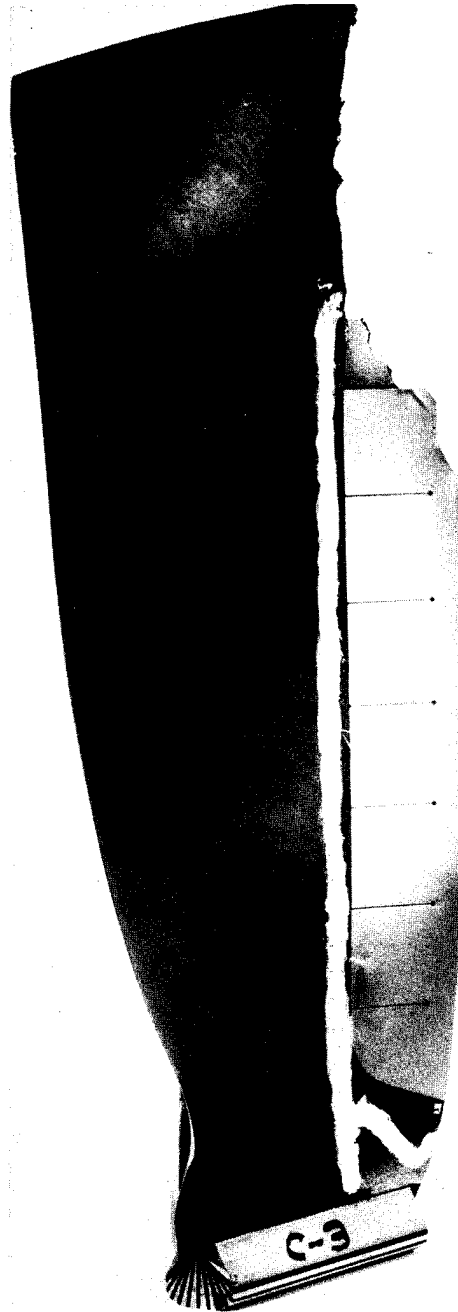
Figure 32 Visual Damage to Graphite/Epoxy Blade C-3 Following Impact with 165g Gelatin Ball

Blade C-3 sliced 105g (3.7 oz) from the 165g (5.8 oz) gelatin ball which impacted the blade leading edge at Section K-K. Visual damage is shown in Figures 32 and 33. Ultrasonic indications after testing were in the areas labeled as delamination in Figure 32.

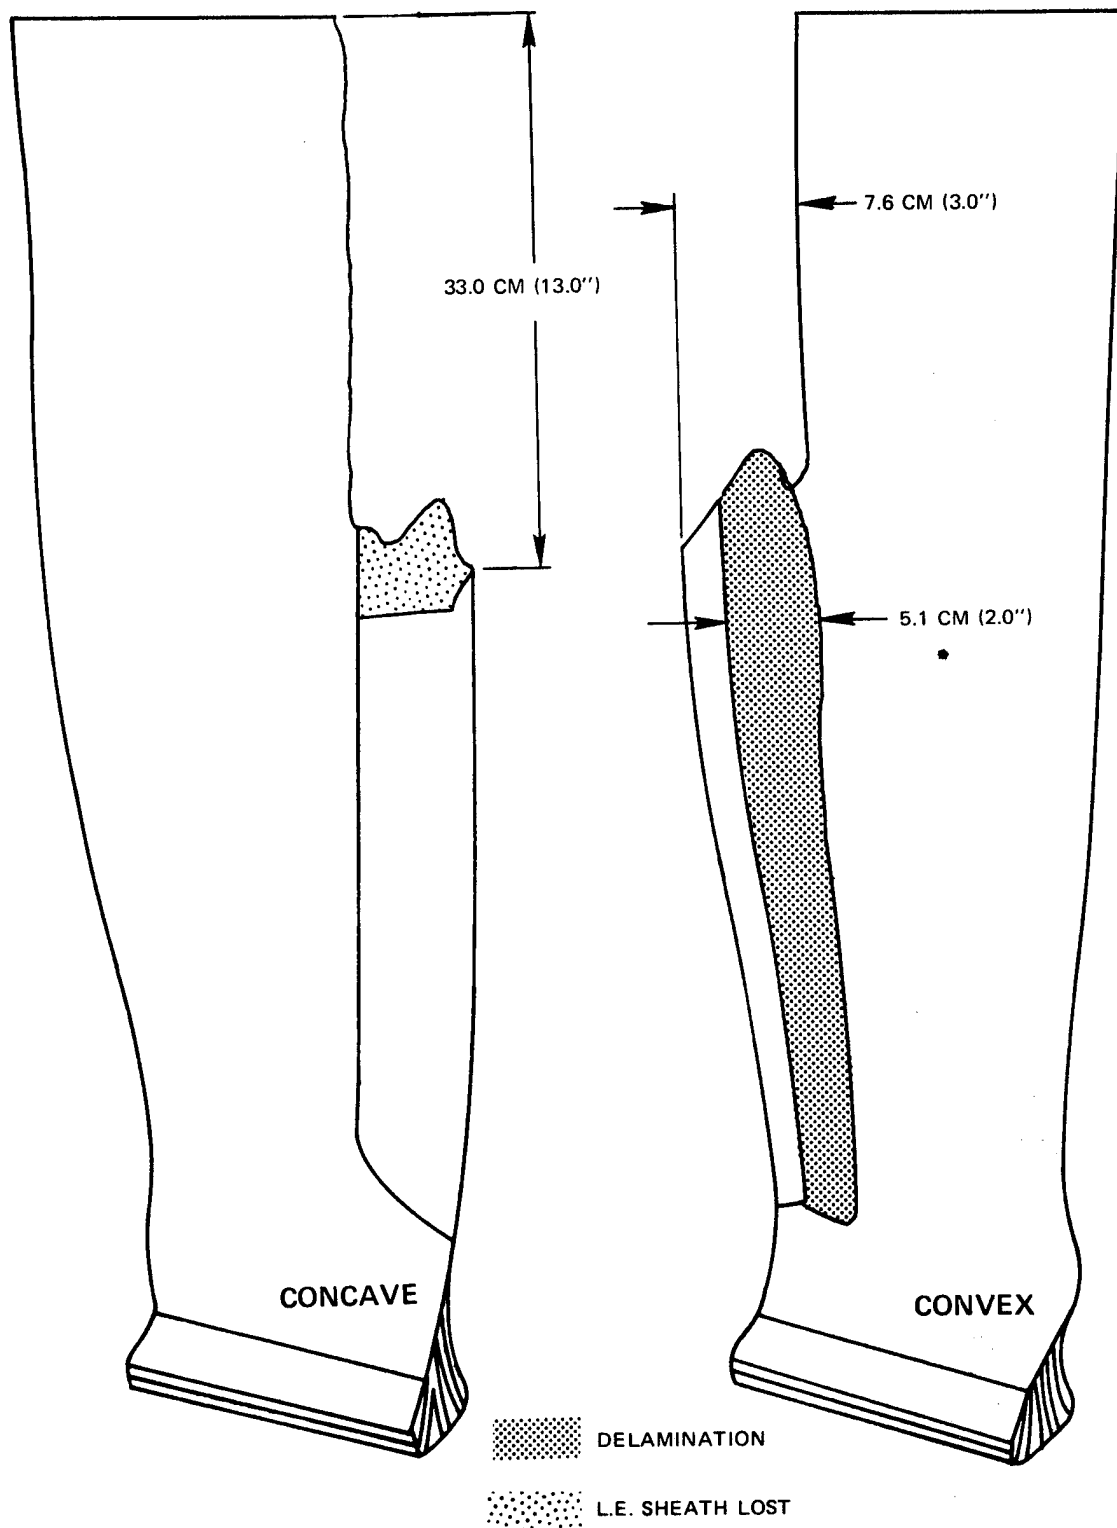
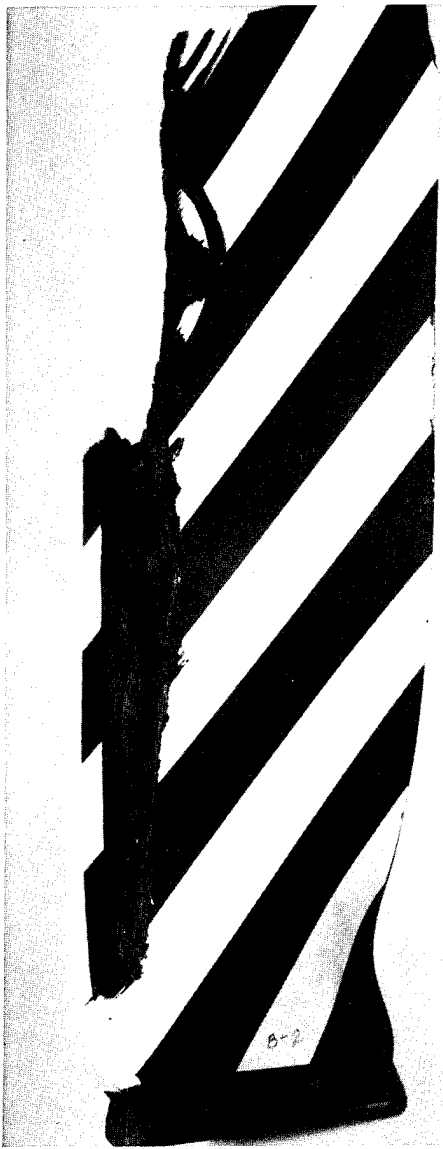
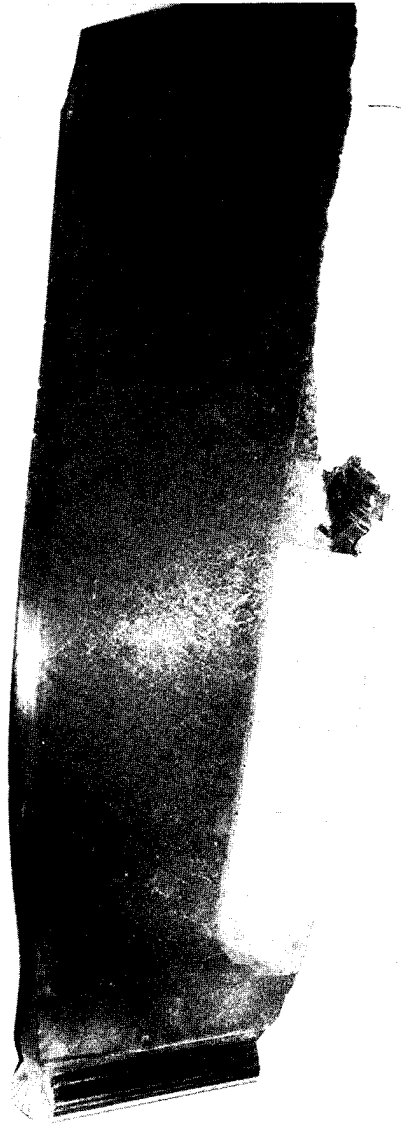
Figure 34 Visual Damage to Boron/Epoxy Blade B-2 Following Impact with 320g Gelatin Ball

In the test of boron/epoxy blade B-2, a slice greater than one-half of the 320 g (11.2 oz) gelatin ball was taken. The 210g (7.4 oz) slice impact caused the damage shown in Figures 34 and 35. No ultrasonic indications were found on blade B-2 following testing.

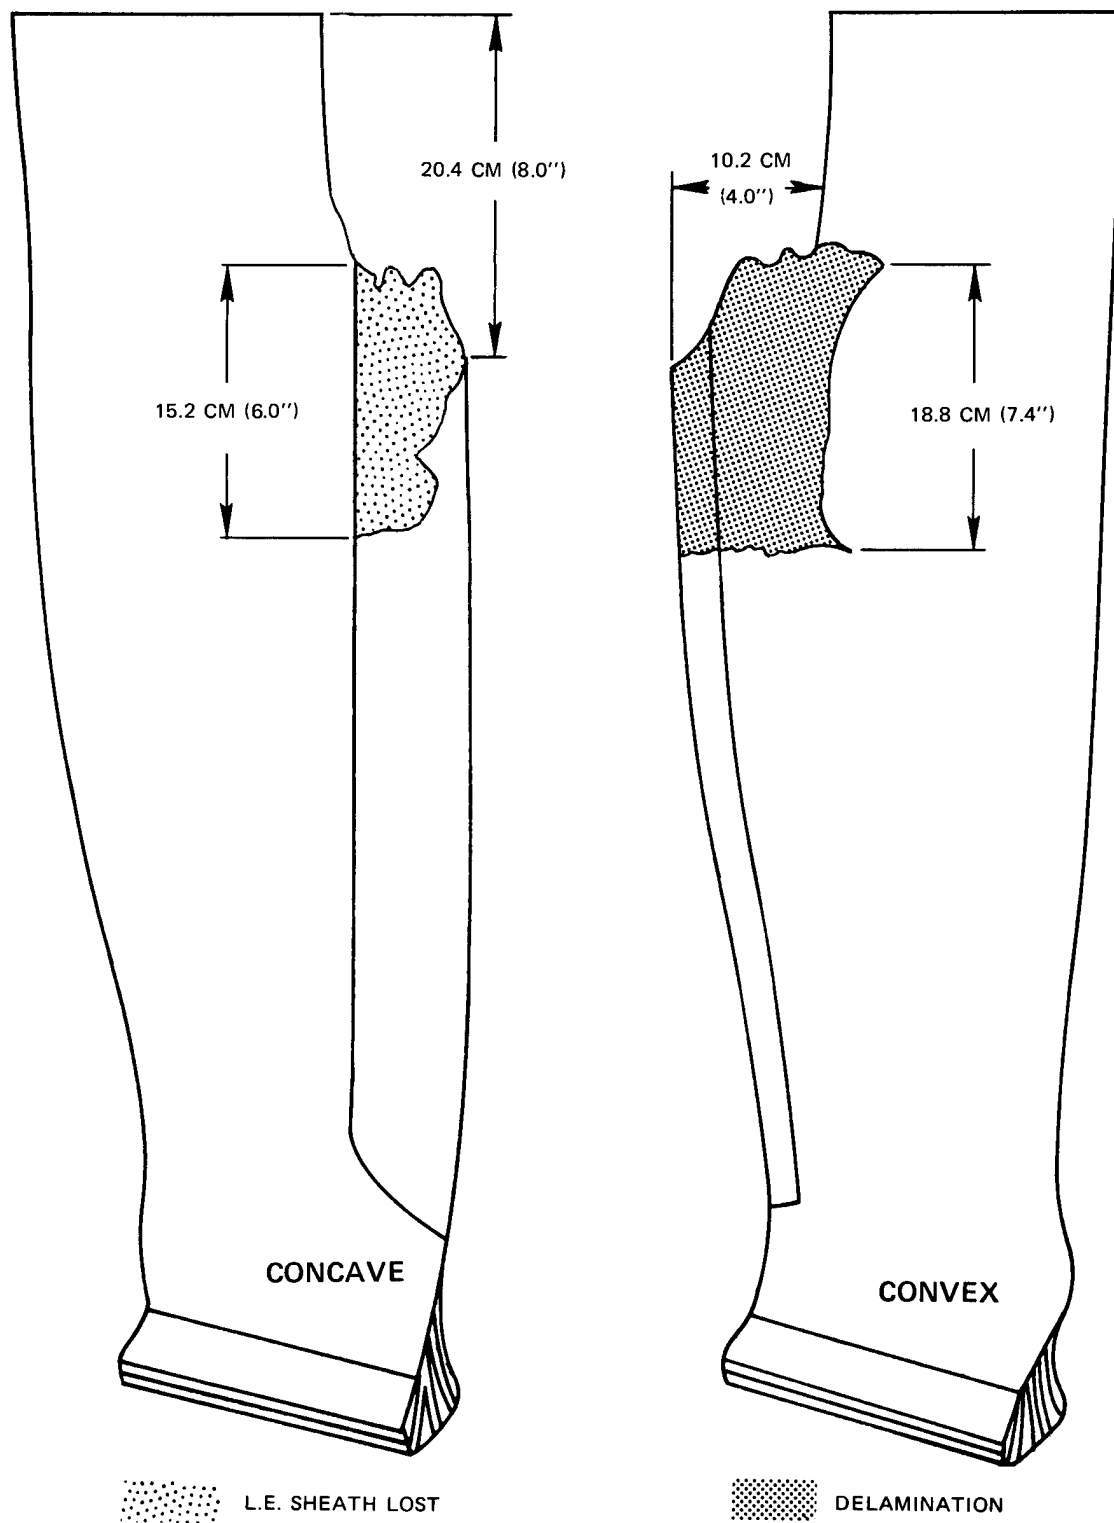
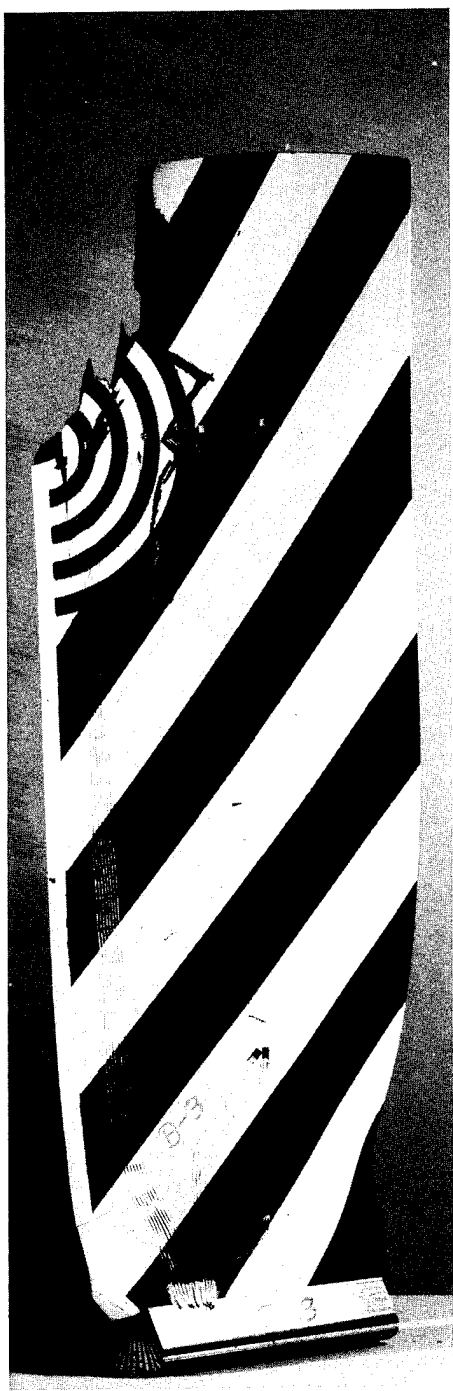
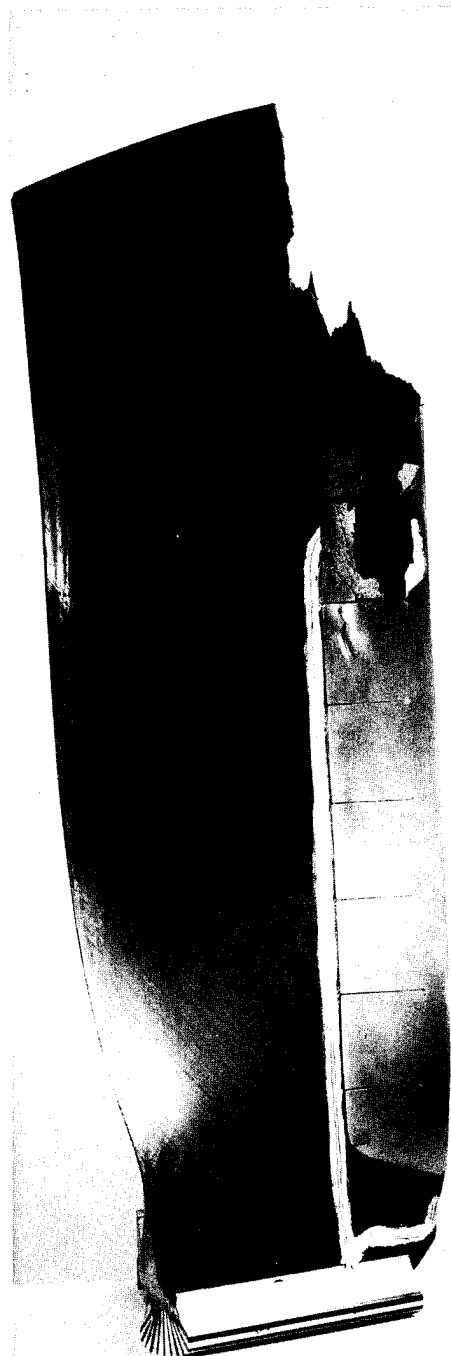
Figure 36 Visual Damage to Boron/Epoxy Blade B-3 Following Impact with 165g Gelatin Ball

Boron/epoxy blade B-3 was impacted with a 165 g (5.8 oz) gelatin ball, however, a malfunction in the drop mechanism caused only a 25g (.9 oz) slice to be taken. The blade was visually and ultrasonically inspected following this impact and found to be undamaged. Blade B-3 was then retested with a new 165g gelatin ball. A 130g (4.6 oz) slice was cut from this ball and blade damage did occur as shown in Figures 36 and 37. Post-test ultrasonic indications correspond to the area shown as delaminated in Figure 36.

The FOD threshold for boron/epoxy blades was determined to be below a 130g (4.6 oz) gelatin ball slice size from the B-3 impact test. However, the severity of damage with the 210g (7.4 oz) slice taken by blade B-2 was not significantly worse than the B-3 damage.

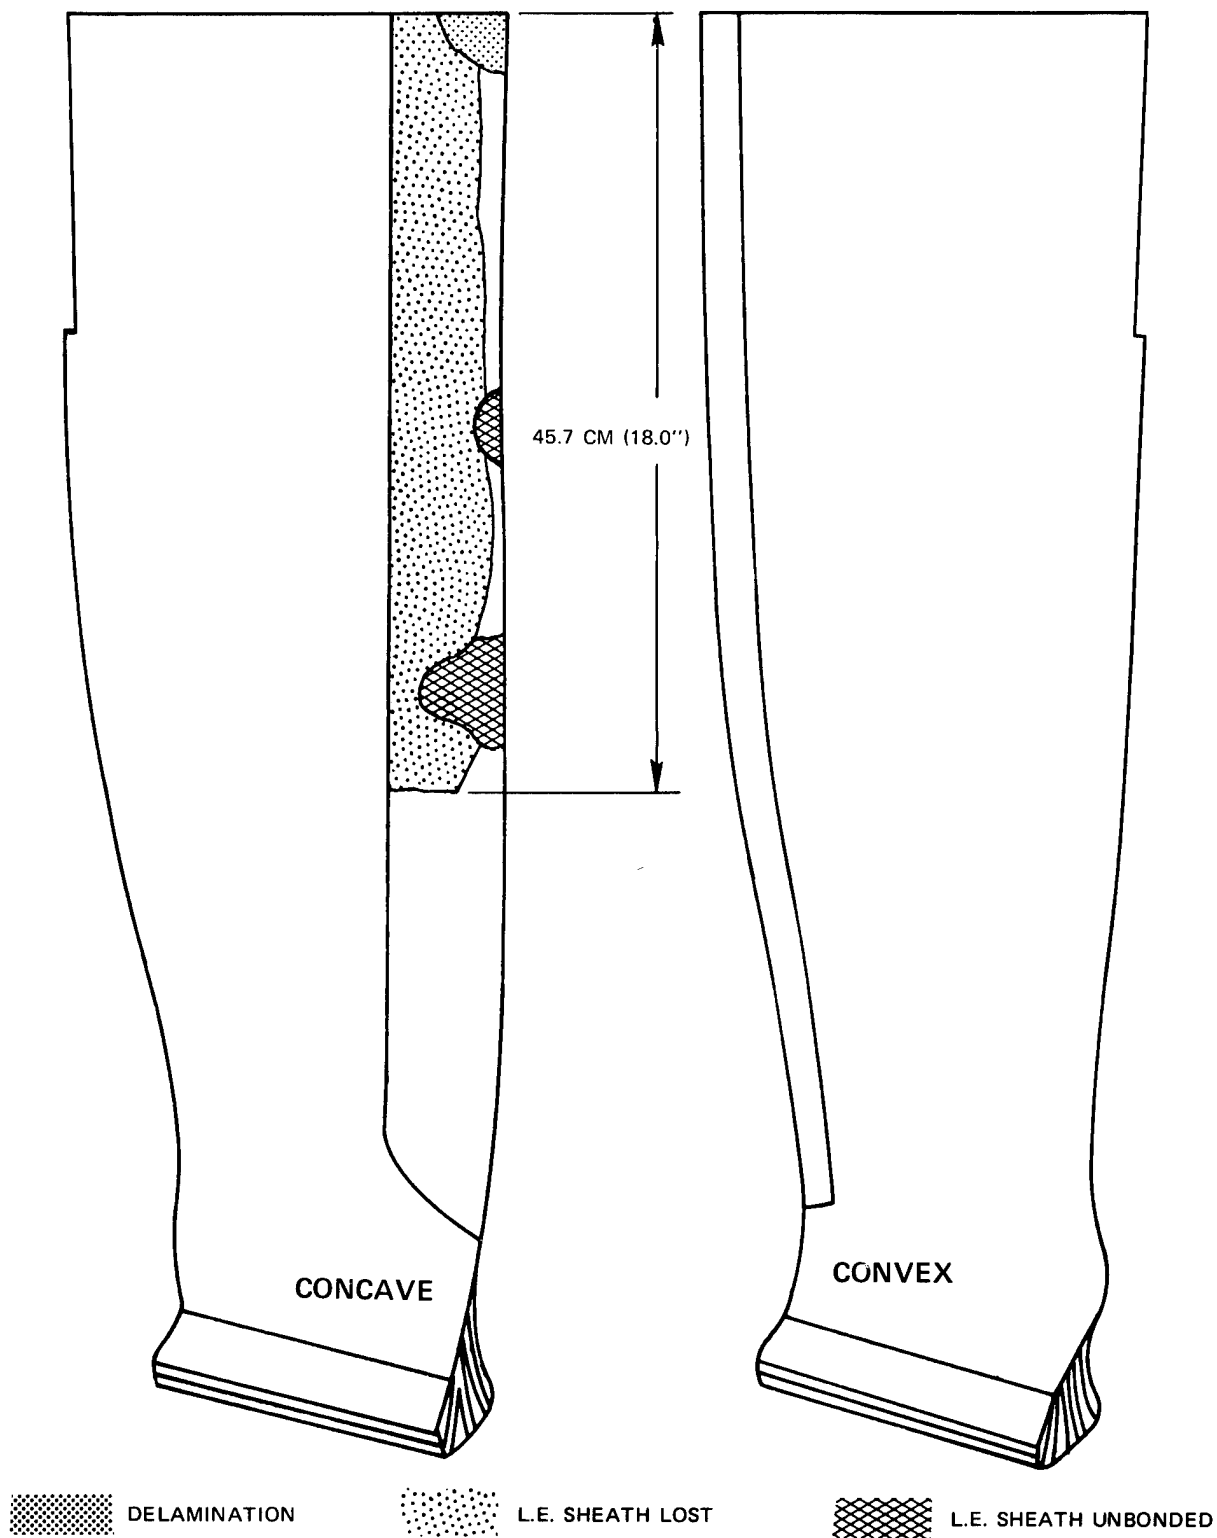
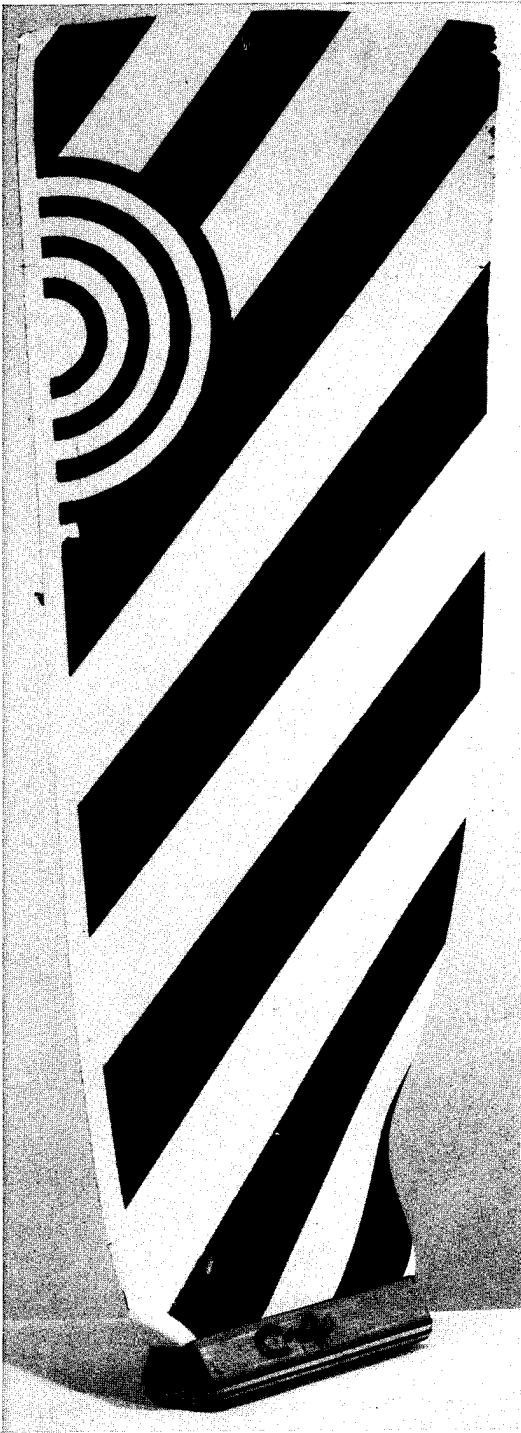
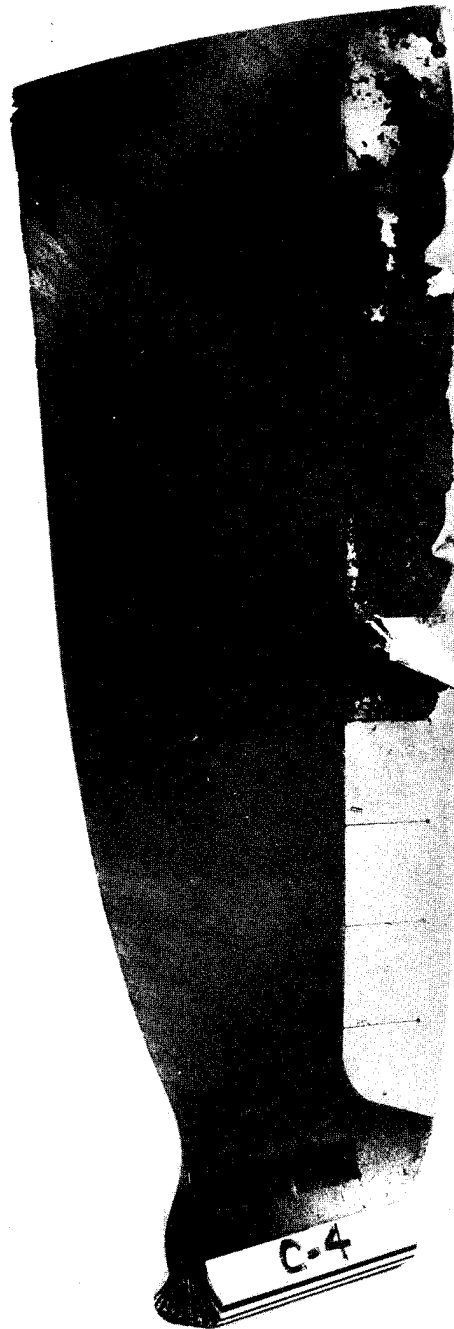
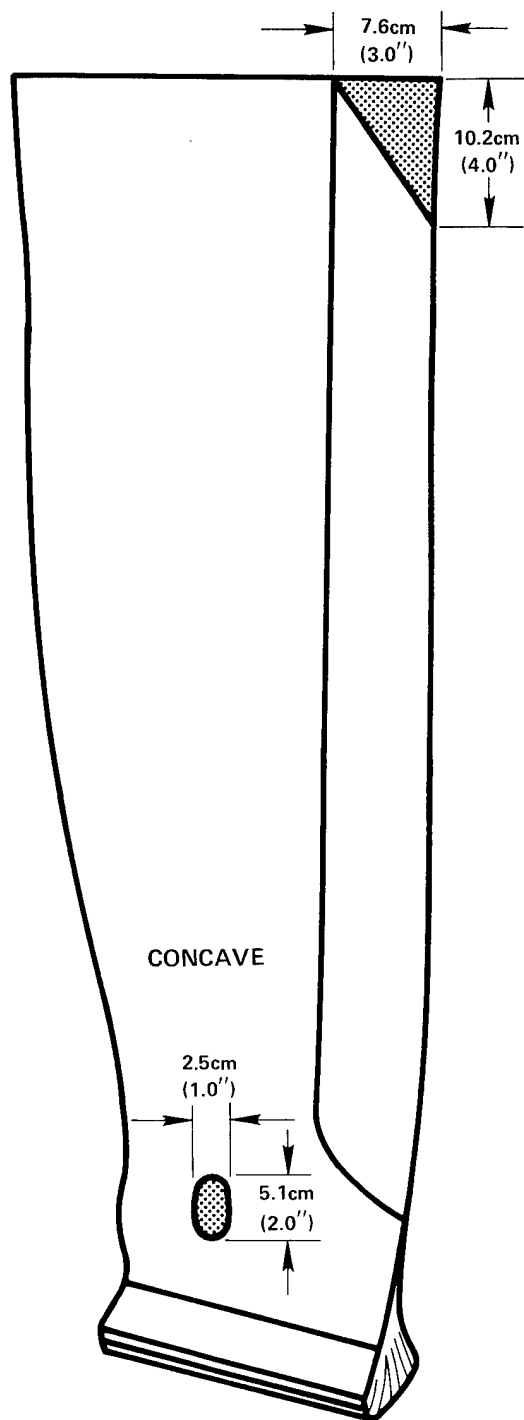
Figure 44 Visual Damage to Graphite/Epoxy Blade C-4 Following Impact with Gravel

Blade C-4 and B-4 were each impacted with 30g (1.1 oz) of gravel. The leading edge sheath on the concave side of C-4 came off the blade as shown in Figures 44 and 45. This failure indicates the possibility of a poor bond between the blade and sheath, although pre-test NDI showed no lack of bonding. Post-test ultrasonic inspection showed indications in the two areas illustrated in Figure 46.

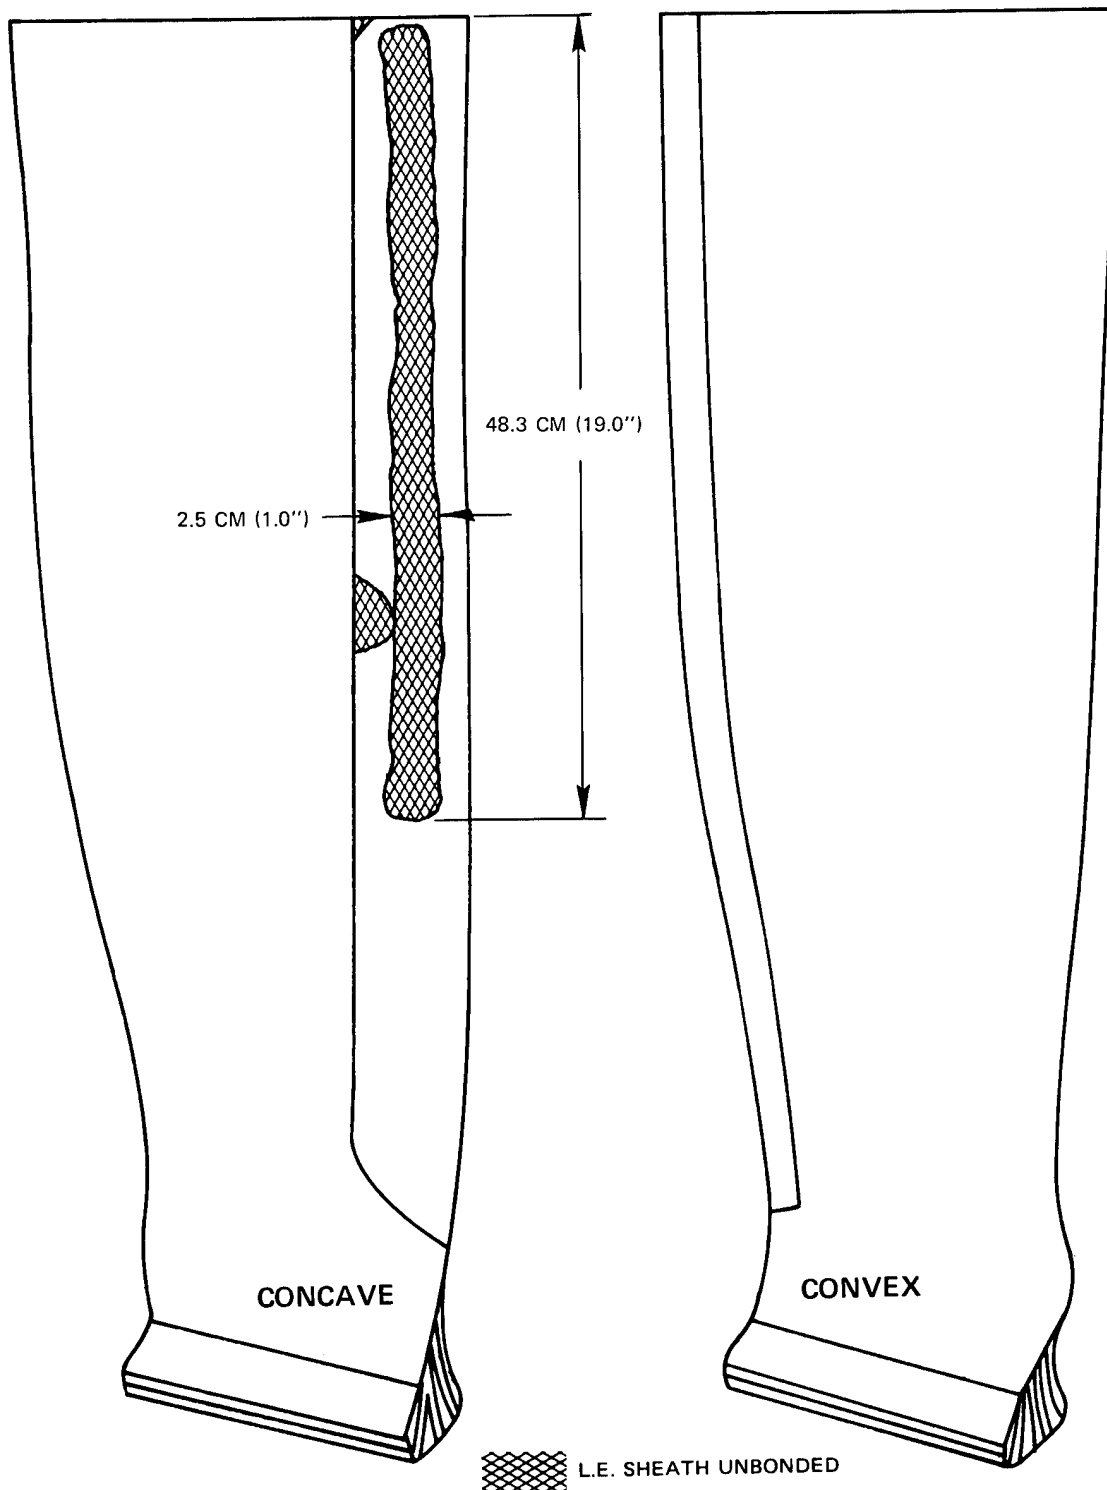
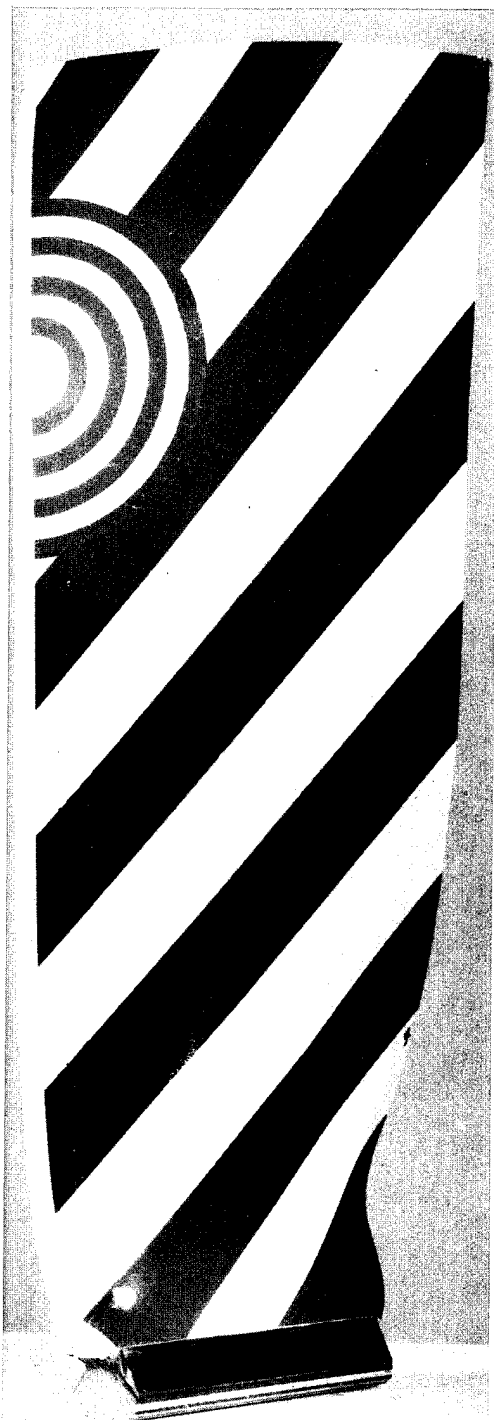
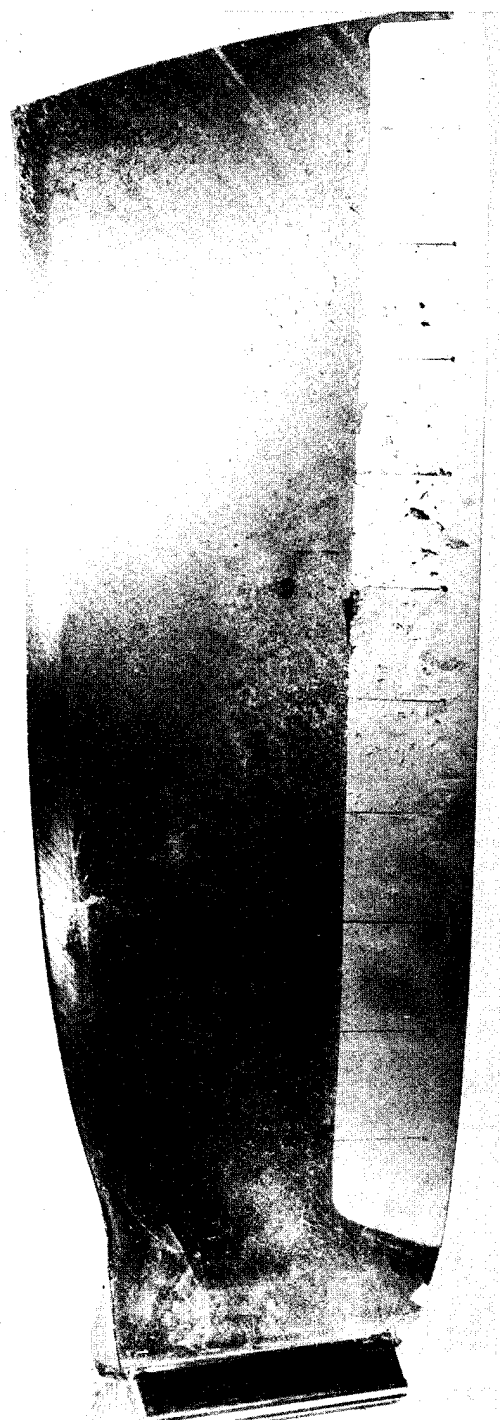
Figure 47 Visual Damage to Boron/Epoxy Blade B-4 Following Impact with Gravel

The gravel impact results on blade B-4 are shown in Figures 47 and 48. No ultrasonic indications were found after testing. Damage at the leading edge is negligible, even though the high-speed movies show that impacts did occur at this location. However, the concave side sheath, aft of the leading edge, was nicked, gouged, and unbounded, as pictured in Figure 49. The gravel apparently strikes the sheath causing compressive stresses on the sheath exterior surface. The stress differential within the sheath is great enough to break the sheath-to-blade bond and then lift the sheath from the surface of the blade. Therefore it is concluded that with a better bond between sheath and blade, the leading edge sheath could offer satisfactory protection from small amounts of gravel ingestion.
